# Here are guidelines for inspecting AST internals

Steve Caruthers Tank Consultants Inc. Tulsa

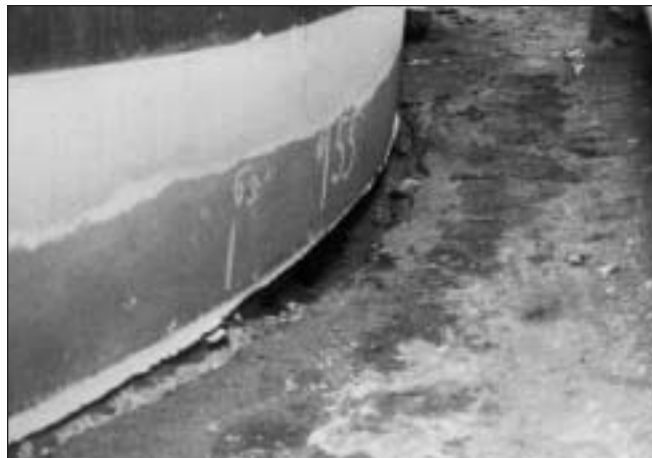
*Exterior tank inspection has turned up bottom sketch-plate deterioration (Fig. 1).*

- **Shell.** The shell should be completely "as built." All details and dimensions of appurtenances should be recorded. The shell should be examined for coating deterioration, distortion, and corrosion (Fig. 1).

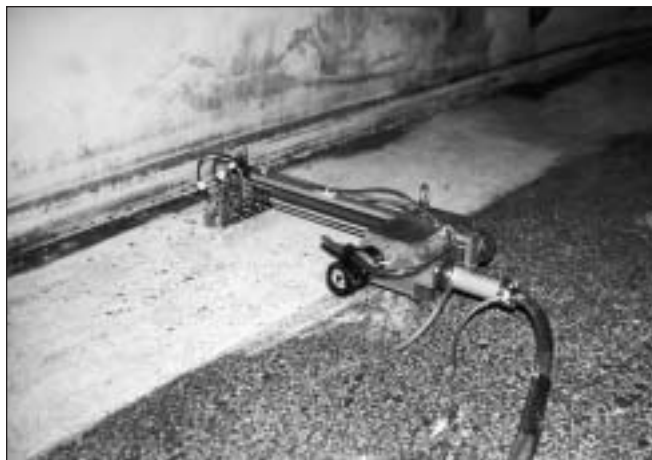
Here's an example of an automated ultrasonic bottom-scanning device (Fig. 3).

At least six different MFE scanners are available on the market (Fig. 3). These have a variety of magnets, sensors, displays, power supplies, propulsion, colors, etc.; all are expensive.

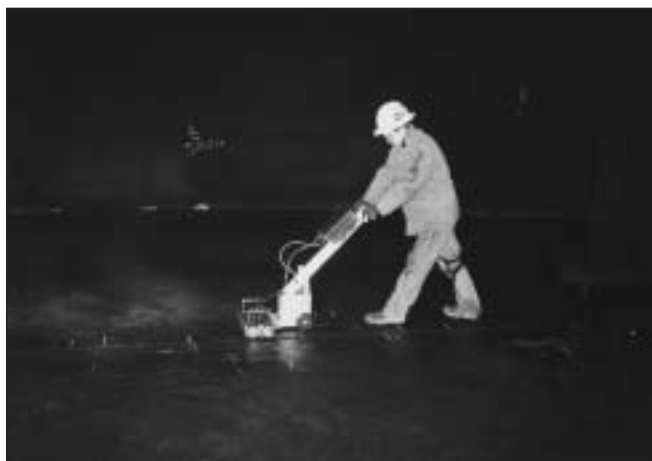
A qualified operator runs an MFE device over a tank bottom (Fig. 4).

- *MFE operator qualifications.* The scan operator should be certified as a Level II (defined by ASNT SN-TC-1A) by the contractor's procedure. This operator should have papers showing that he is trained and tested (Fig. 4).

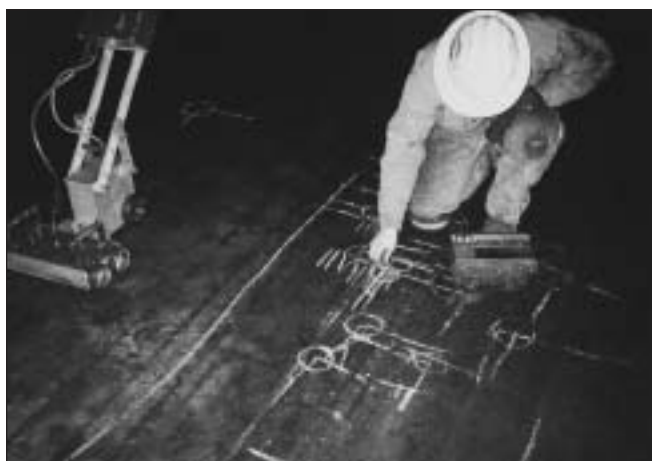
MFE scan has indicated soilside metal loss (Fig. 5).

- All verified indications should be marked on the bottom with spray paint. Top side indications should be marked with circles; soil-side with squares (Fig. 5).
